Inspection Report

zimmelhomeinspections

123 Fake St
Port Angeles, WA 98362

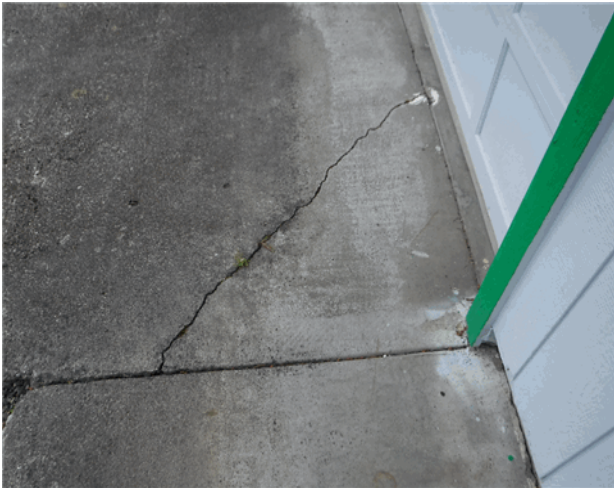
2) Driveway Conditions AS Common cracks were observed in the driveway.

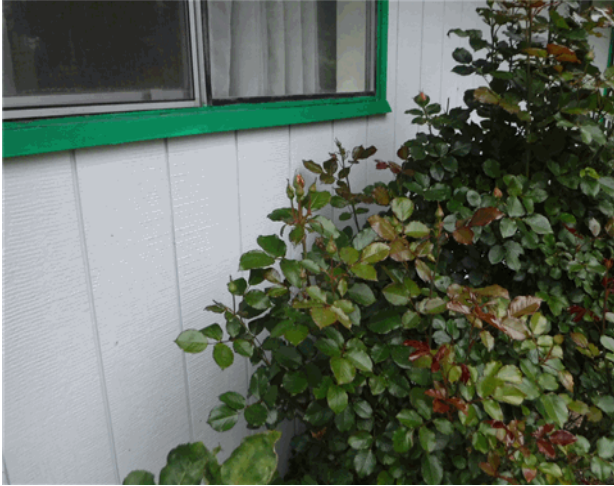
4) Vegetation Conditions R Cut back the vegetation on the south side of the home. Keeping a one foot air gap between the pants and siding is recommended to help keep moisture off the house.

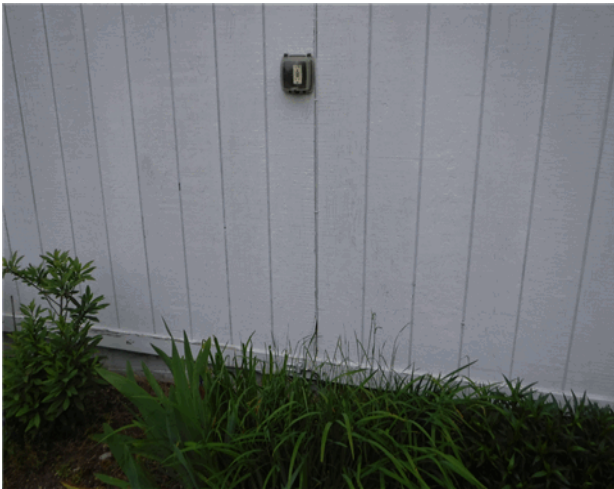
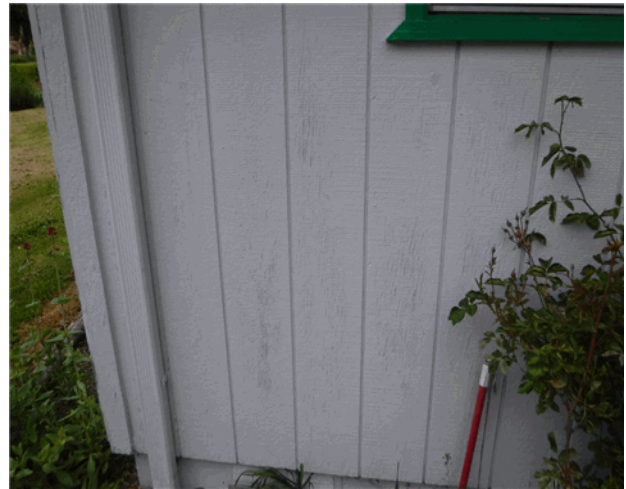
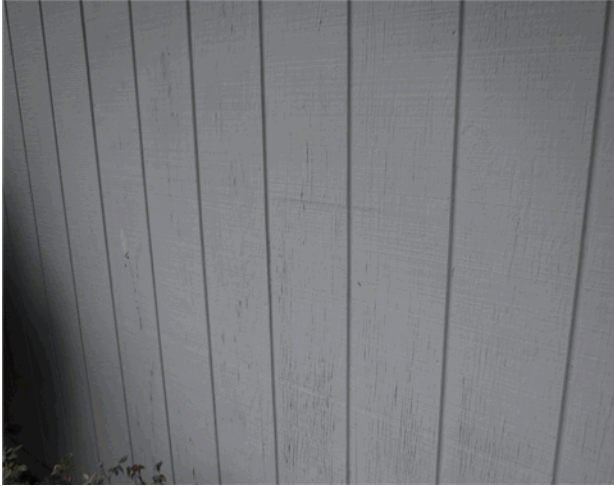
The paints was cracking on the south and west sides of the home. I recommend scraping off any loose paint and re-painting.

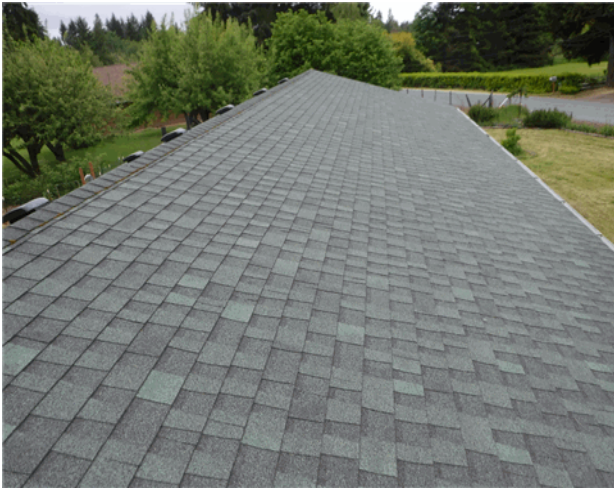
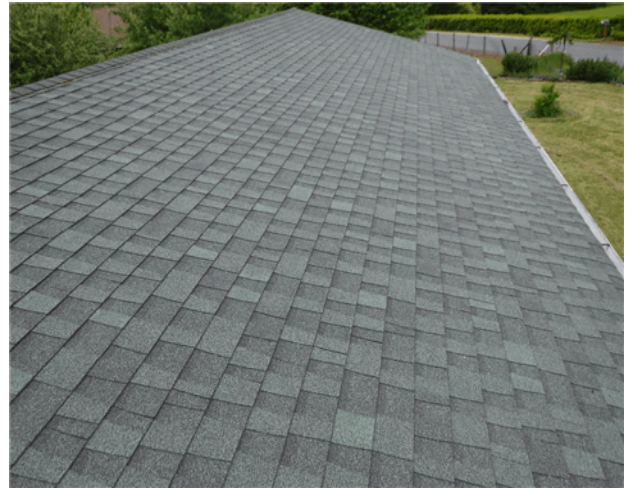
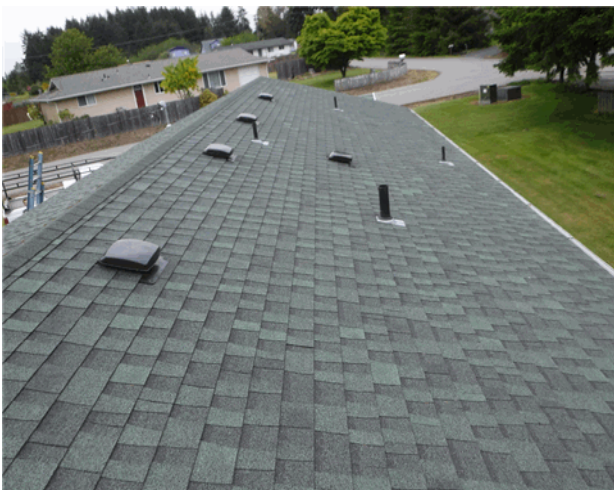
12) Roof Covering Condition R The roof covering shows normal wear for its age and appeared to be in serviceable condition at the time of the inspection.

There was a small amount of moss starting on the north peak. I recommend removing the moss and treating the roof every year.

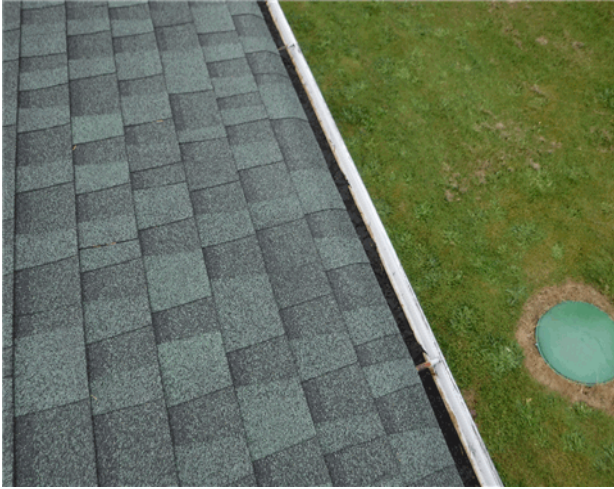
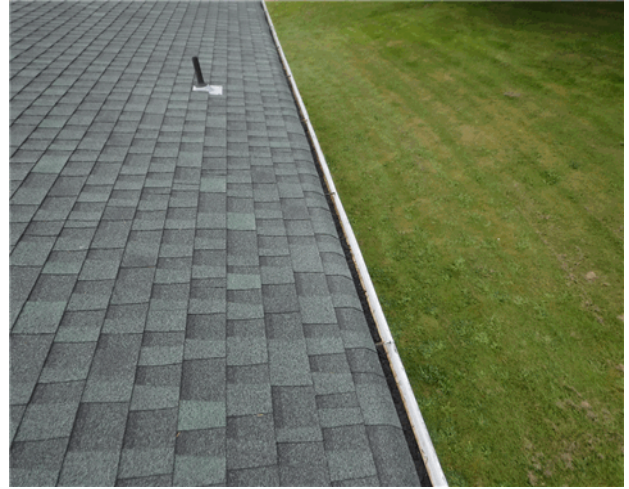
The gutters were filled with leaves and debris at the time of the inspection. Suggest cleaning and removal of debris on a regular basis. This condition can cause water penetration at the eave area.

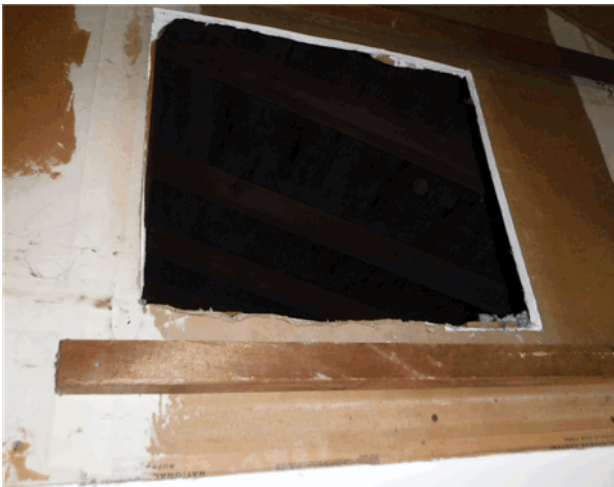
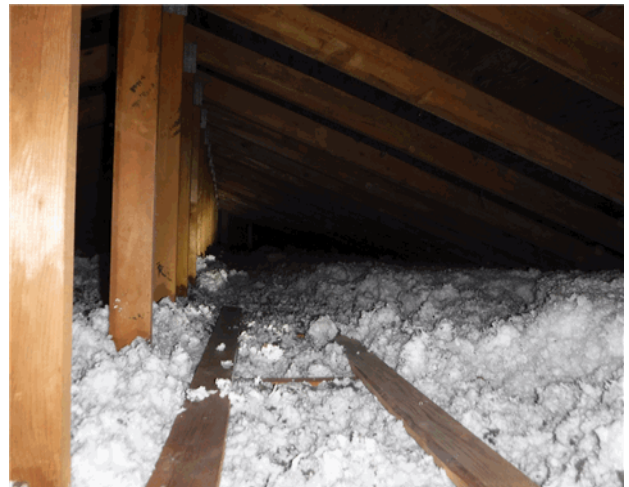
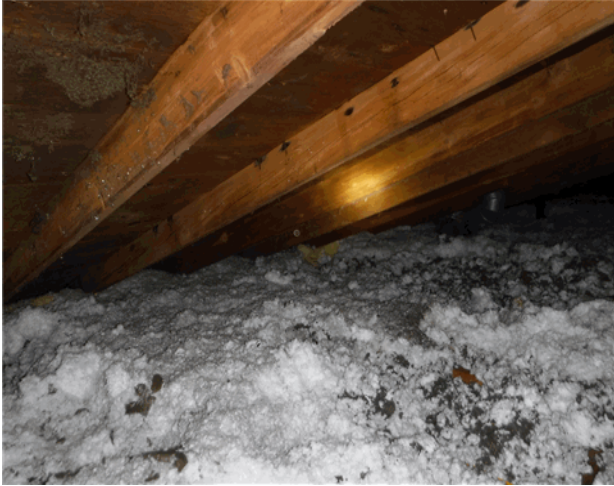
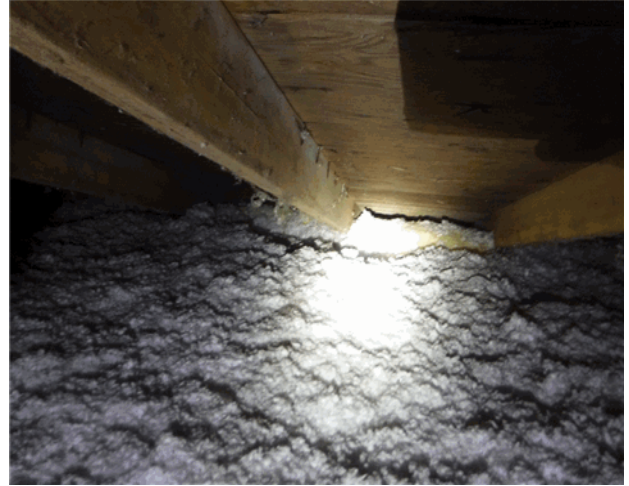
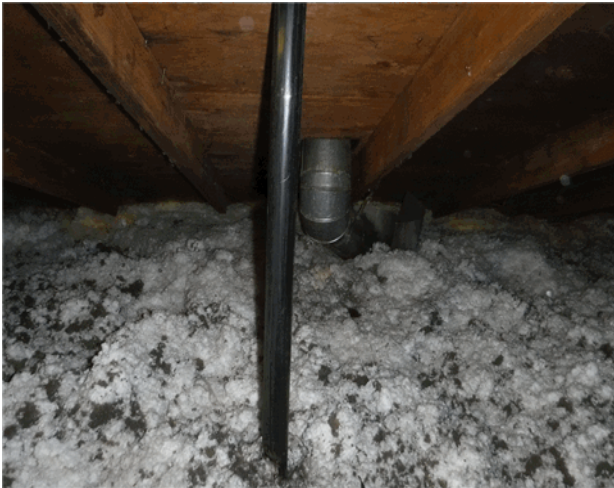
The visible and accessible portions of the attic appeared to be in serviceable condition at the time of the inspection.

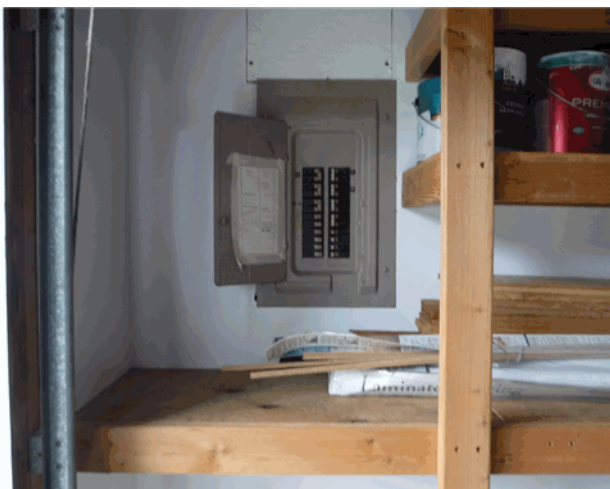
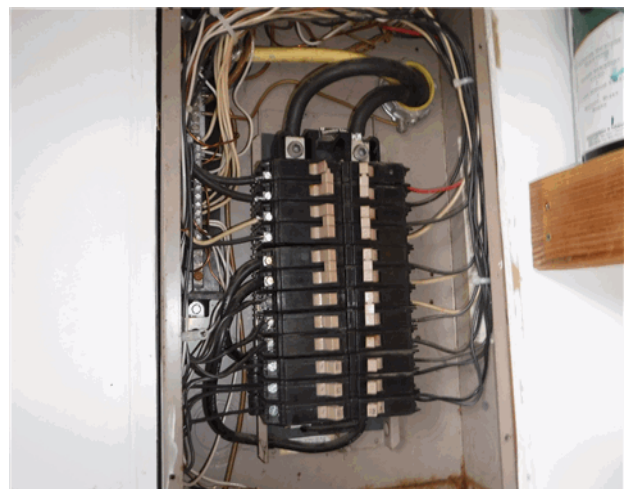
Double tapped breakers

22) Electrical Panel Conditions R The panel is an older style and has no main breaker.
There were two breakers that were double tapped. I recommend having an electrician split these breakers and put circuits on their own breakers.

The panel had a bench built in front of it. This is never recommended and nothing should block the electrical panel.

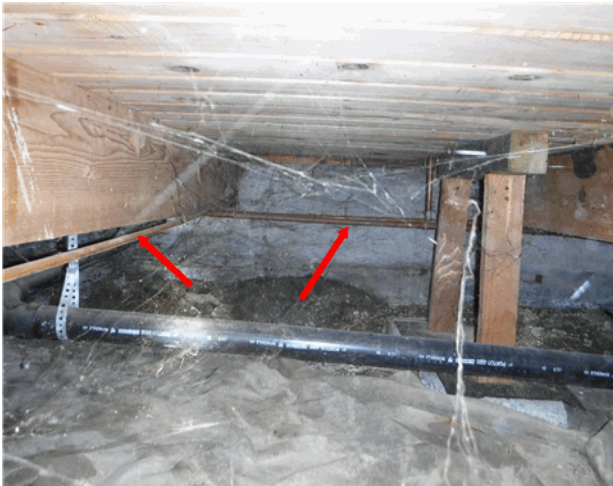
24) Supply Line Conditions R Since the pipes can be exposed to cold temperatures, recommend installation of insulation wrap at all valves and associated piping. Although insulation can be purchased at most hardware stores, client is advised to consult with a licensed plumber for information on piping within unheated areas.

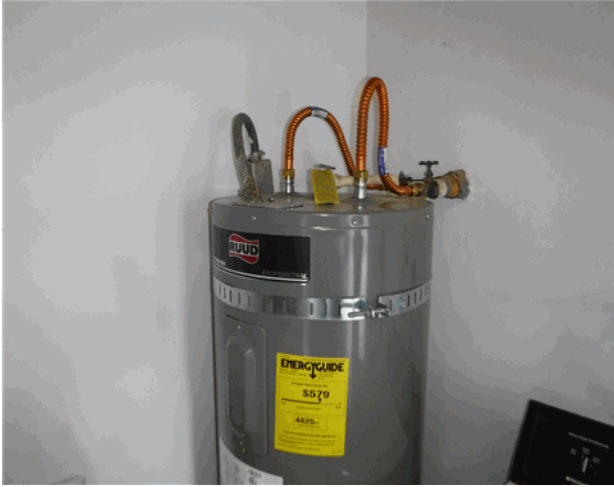
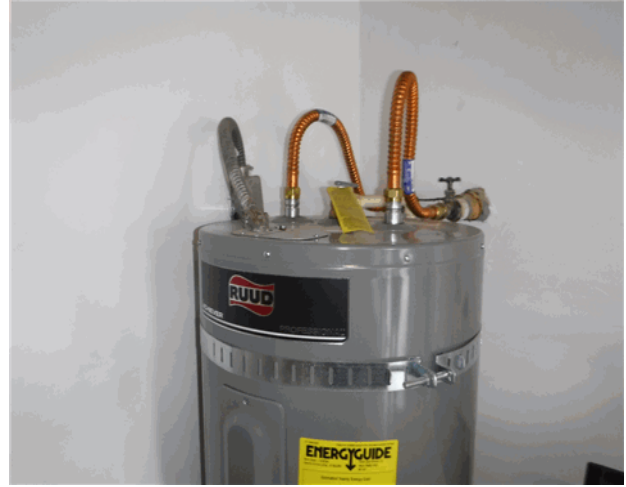
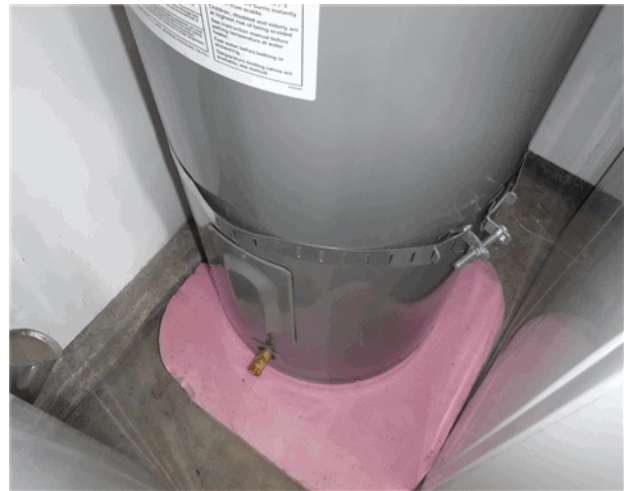
The water heater was operable at the time of inspection. This does not however guarantee future performance, operation, or condition. The water heater is from 2014.

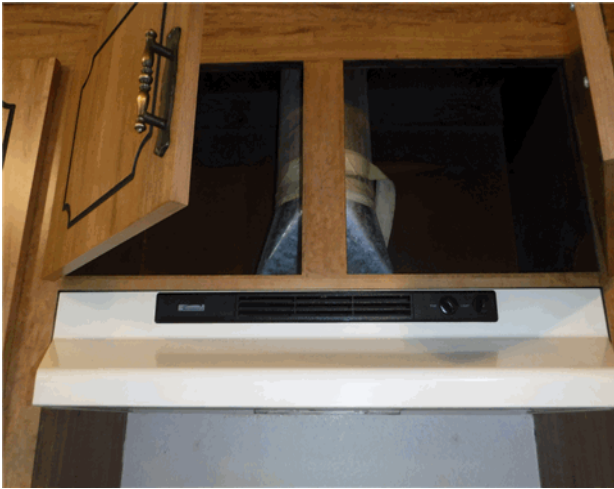
The hood fan is vented out through the roof but appears to be sending the air out the front of the grill. Check to make sure the air is directed out through the vent.

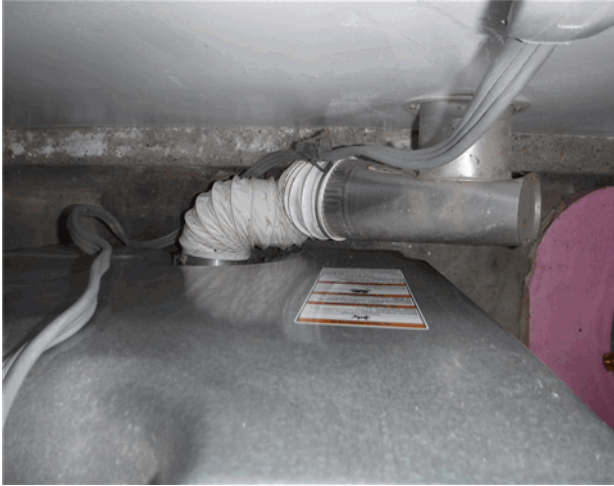
Location		Garage
70) Laundry Room Conditions	R	For increased fire safety, any flexible duct should be replaced with hard metal duct to reduce lint build up. The accumulation of lint can become a fire hazard. Cleaning is recommended on an annual basis.

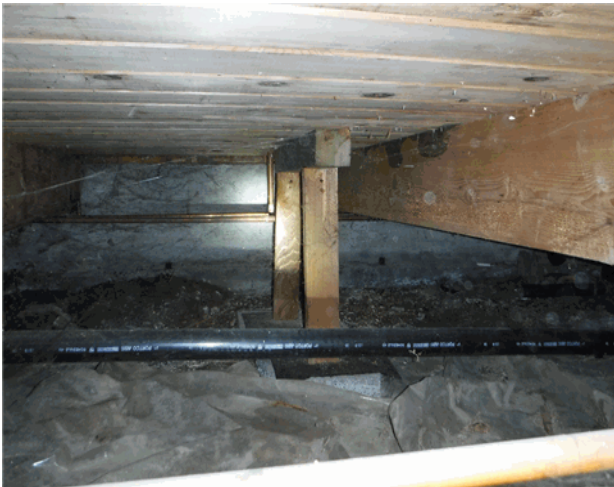
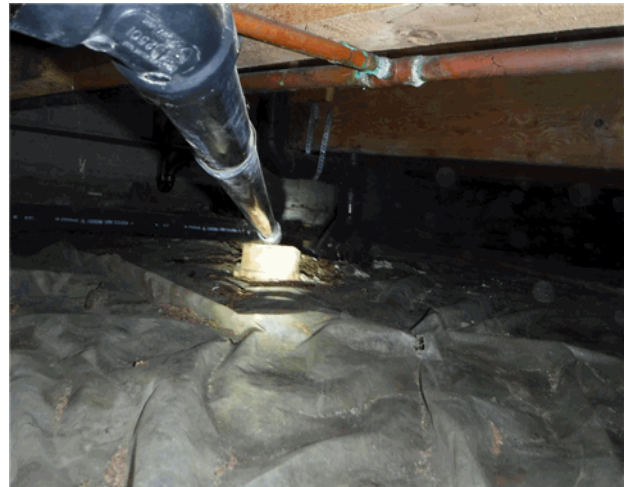
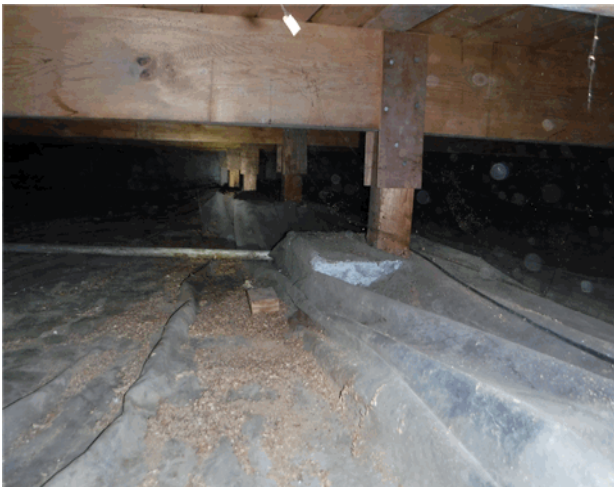
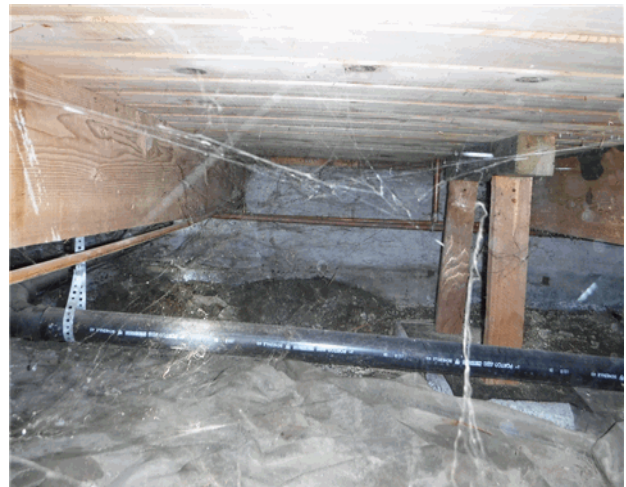
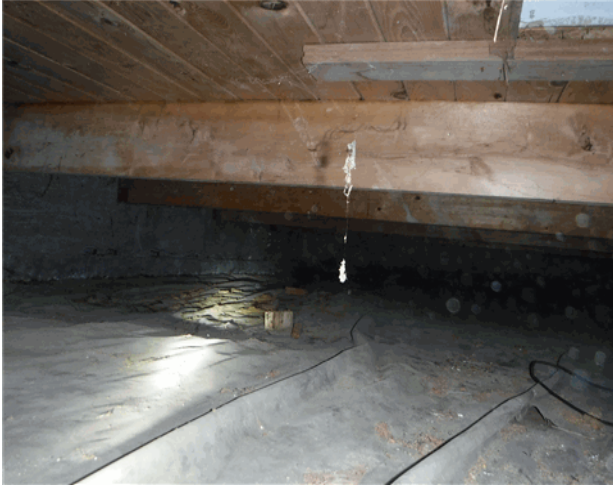
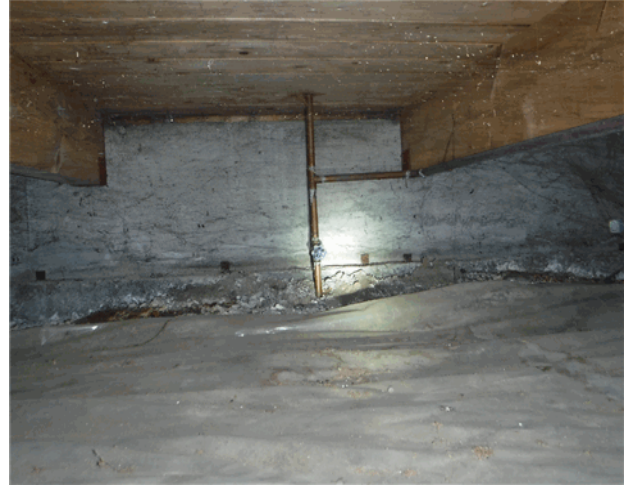
72) Flooring Support Conditions AS The visible and accessible areas of the wood framing system appeared to be in serviceable condition at the time of the inspection.

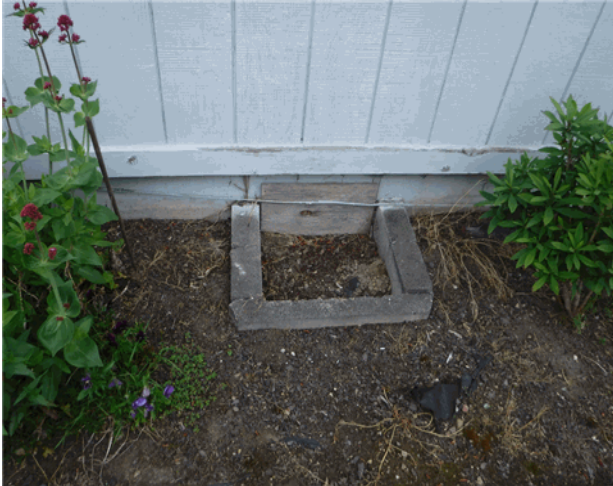
R The vents were all blocked at time of inspection and need to be opened up. These vents are there for air circulation and I recommend to never cover them.
